Above the Flood: Elevating Your Floodprone House

FEDERAL EMERGENCY MANAGEMENT AGENCY

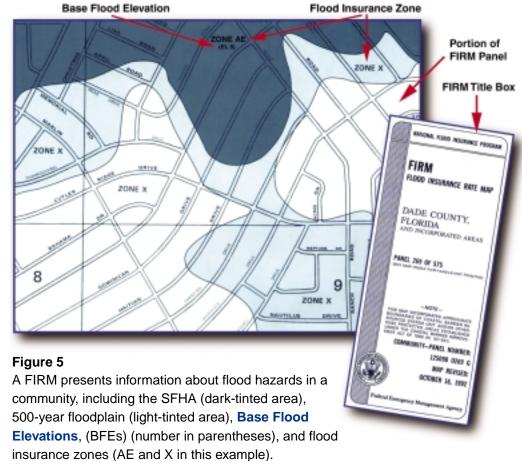
| Figure 1 | Hurricane Andrew was a Category 4 hurricane with peak winds of over 140 mph | 1-1 |
|---|--|---|
| Figure 5 | A FIRM presents information about flood hazards in a community, including the SFHA (dark-tinted area), 500-year floodplain (light-tinted area), Base Flood Elevations (BFEs) (number in parentheses in dark-tinted area), and flood insurance zones (AE and X in this example). | 2-2 |

Communities participate in the NFIP by enacting and enforcing floodplain management regulations to reduce future flood risks. At a minimum, these regulations govern construction in the **Special Flood Hazard Areas (SFHAs)** shown on Flood Insurance Rate Maps (FIRMs) issued by FEMA (Figure 5).

Note that the SFHA in the example in Figure 5 is designated Zone AE. This zone is only one of several applied to SFHAs under the NFIP, including V, VE, V1-V30, A, AE, A1-A30, AO, and AH. These zones indicate differences in the types and severity of flood hazards in SFHAs. For the purposes of this publication, it is sufficient to focus on the basic differences between the two main types of SFHA zones—V zones and A zones. The distinction is important because regulatory requirements associated with V zones and A zones differ significantly. As explained later in this chapter, these requirements affect the types of building elevation techniques that may be used under the NFIP.

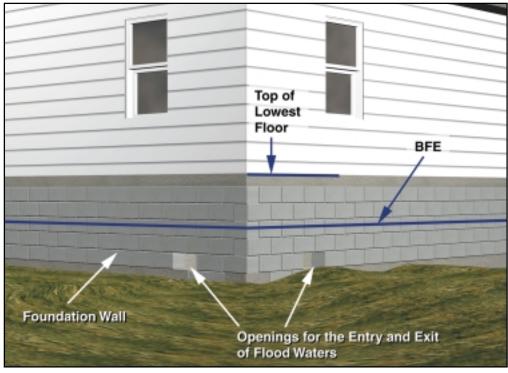
Figure 6

In a new, substantially improved, or substantially damaged building in an A zone, the elevation of the lowest floor must be at or above the BFE.

In A zones, where flood hazards are less severe, buildings may be elevated either on an open foundation or on continuous foundation walls below the BFE (Figure 6). Regardless of the type of foundation used, A-zone buildings must be elevated so that the **lowest floor** is at or above the BFE, as shown in Figure 6. If continuous walls are used below the BFE, they must be equipped with openings that allow flood waters to flow into and out of the area enclosed by the walls (Figure 6). Allowing the entry and exit of flood waters ensures that water pressures will be the same on both sides of the walls and reduces the likelihood that water pressure will cause the walls to fail.

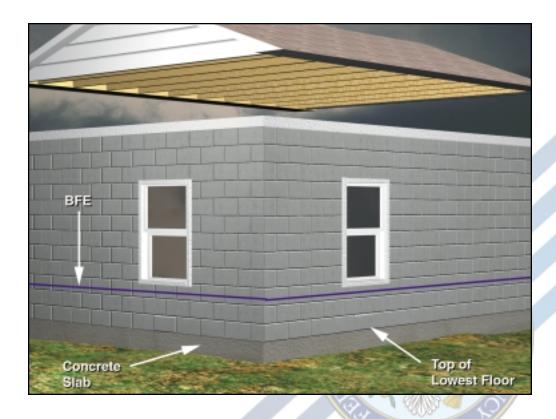
Figure 10 The first step in Technique 1 is removing the roof.

Technique 1 is appropriate for houses with concrete or masonry walls, but not for houses with other types of walls, such as those framed with wood studs, which would be more vulnerable to flood damage. This technique is usually appropriate when the depth of the base flood at the house is no more than 4 or 5 feet above grade. The elevation process begins with the temporary removal of the roof and roof framing, in a single piece if possible (Figure 10). This is commonly done with a crane. The roof is then stored on site so that it can be reinstalled later. The next step is to remove the windows and doors.

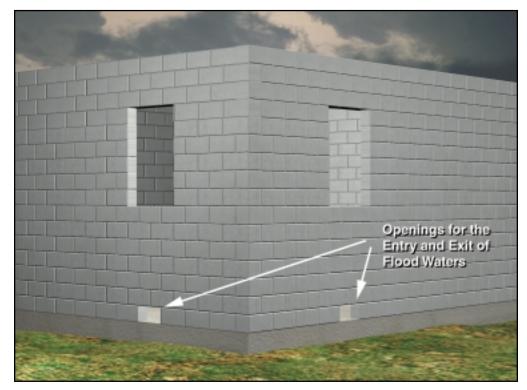
Figure 12 Openings are created in the walls near the ground.

Blocks are removed from the walls of the house at selected locations within 1 foot of the ground (Figure 12). The resulting openings will allow flood waters to flow into and out of the lower area of the house so that the water pressures on both sides of the walls will remain the same. The roof and windows are then replaced, and a new wood-frame floor is constructed above the flood level (Figure 13).

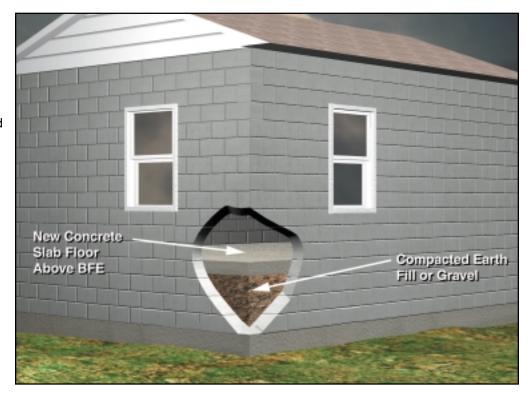
Figure 14

A homeowner who chooses Technique 1 may decide to build a new concrete slab floor instead of a wood floor (Figure 14). When this option is chosen, compacted fill dirt or gravel is placed on top of the old slab and the new slab floor is poured on top. Because the area below the new floor is filled with dirt or gravel, wall openings are not required.

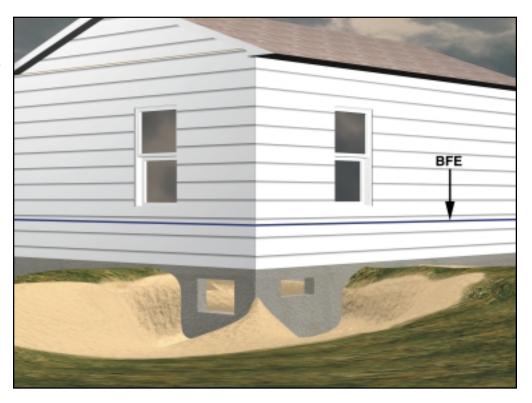
Figure 17

First, trenches are dug to expose the foundation walls immediately below the slab. Holes are then cut in the foundation walls at intervals around the house, and tunnels are dug under the slab (Figure 17). Jacks are placed in the trenches and large I-beams are inserted through the tunnels and allowed to rest on the jacks. Smaller I-beams are then inserted through the tunnels at right angles to the larger beams and positioned on top of them. The smaller beams support the slab when the house is raised (Figure 18).

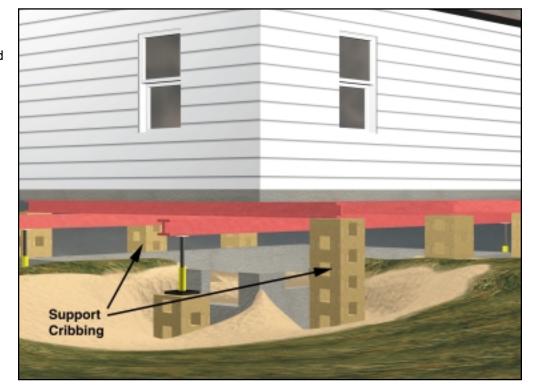
Figure 18 With I-beams and jacks in place, the house is ready to be lifted.

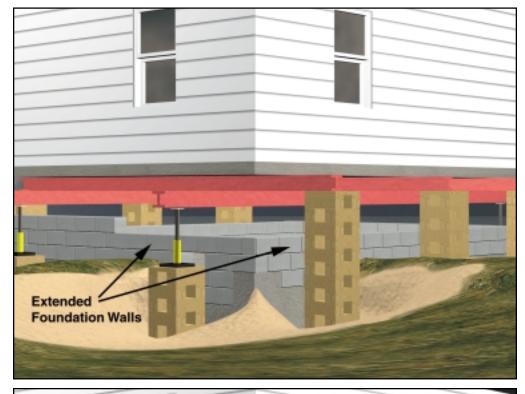
Figure 20 New, extended foundation walls are constructed with concrete blocks.

This process is repeated until the house is raised to the desired height. The foundation walls are then extended upward with additional rows of concrete block (Figure 20). As in the previous techniques, openings are made in the walls within 1 foot of the ground so that flood waters will be able to flow into and out of the area below the elevated floor. The jacks and beams are removed, and the openings left around the beams are filled with blocks (Figure 21).

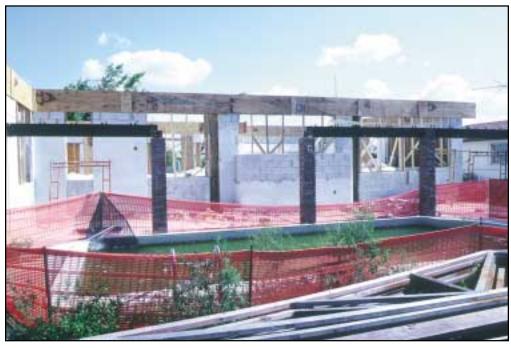
Figure 23

View from the back of the house. The walls have been extended upward with concrete blocks. The plywood visible at the tops of the walls is used to form cast-in-place concrete bond beams that will strengthen the extended walls. The roof trusses shown in the foreground were salvaged for reinstallation. The owner of this house decided to replace the original roof sheathing and shingles with new materials.

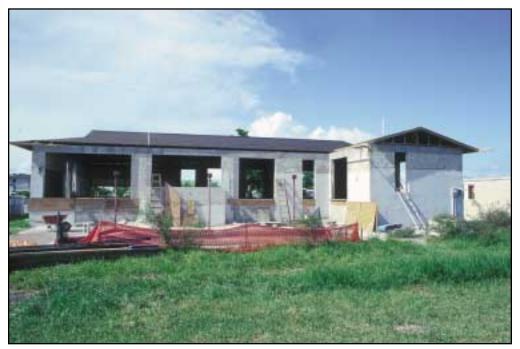
Figure 28 The bottoms of the original window openings are raised with concrete blocks.

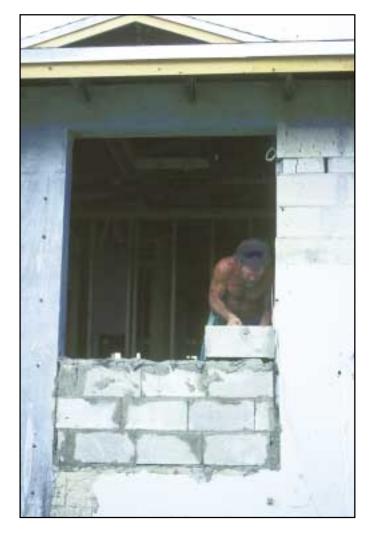
Figure 29 Windows and doors are added. The height of the raised front door shows the amount of elevation.

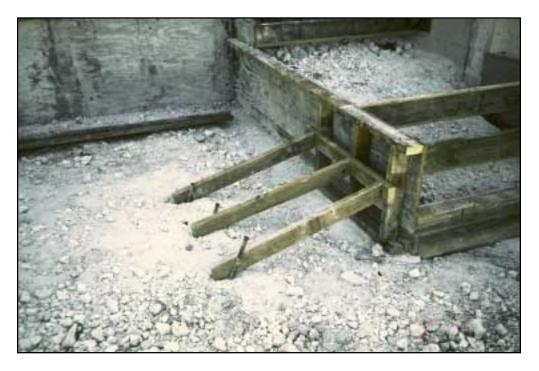
Figure 33 Wood framing for a new concrete staircase that will provide access to the elevated floor.

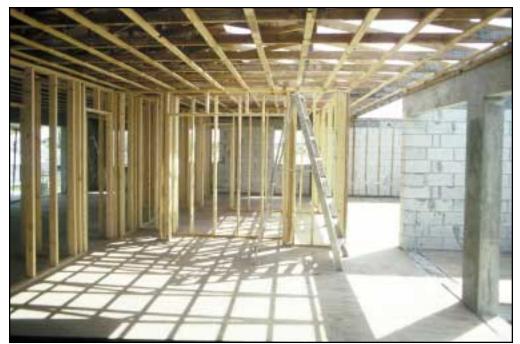
Figure 35

The electrical system is upgraded to meet current code requirements.

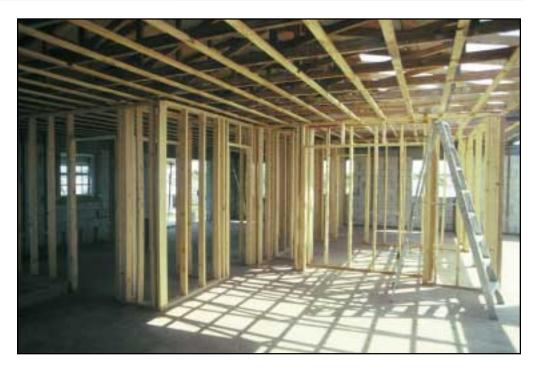
Figure 48 Wood 2 by 4 studs were used to frame the interior walls of the second story.

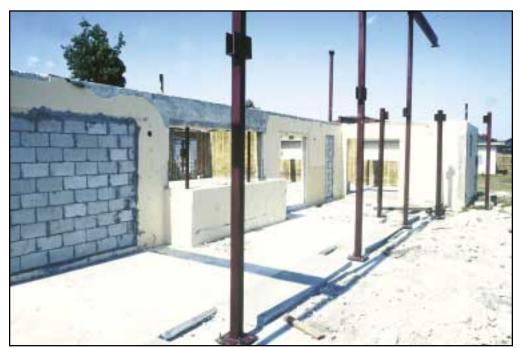
Figure 53

As the second story takes shape, its size in relation to the size of the original house becomes apparent.

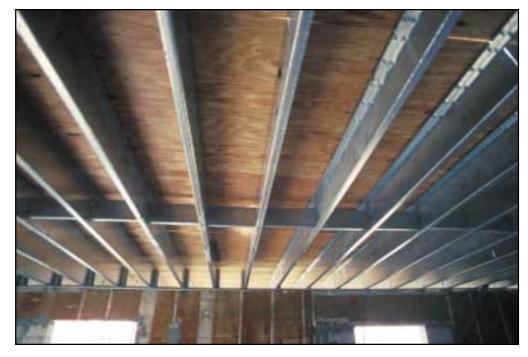
Metal framing also supports the floor of the new second story.

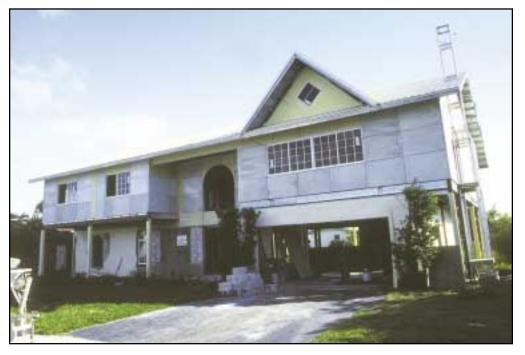
The new second story nears completion. The roof is made of formed metal panels.

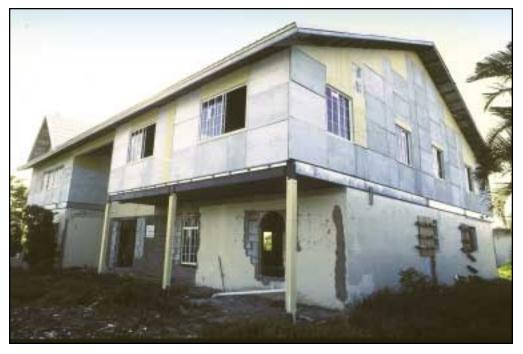
Figure 60

The exterior walls consist of prefabricated concrete panels. Innovative techniques such as those employed in this project are helping homeowners who need practical and economical methods of repairing and protecting their houses.

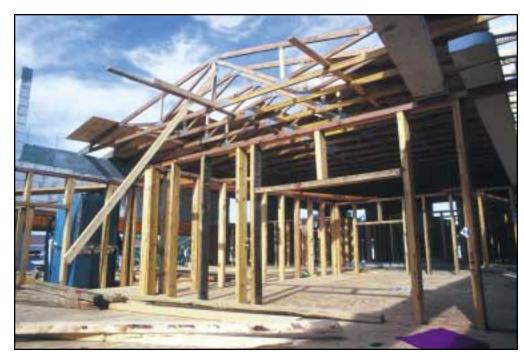
Figure 70

Metal hurricane straps are used to tie the structural members together and create a continuous load path from the roof to the foundation.

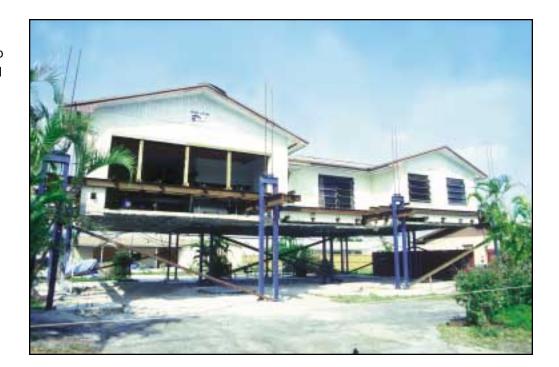
Figure 81 The house and slab were raised one full story.

Lifting the house, while simple in theory, is complicated by the need to ensure an equal amount of lift at each jack throughout the process. Too much or too little lift at even one jack can cause the slab and walls to crack. The elevation contractor for this project used a sophisticated jacking system that provided the required level of control.

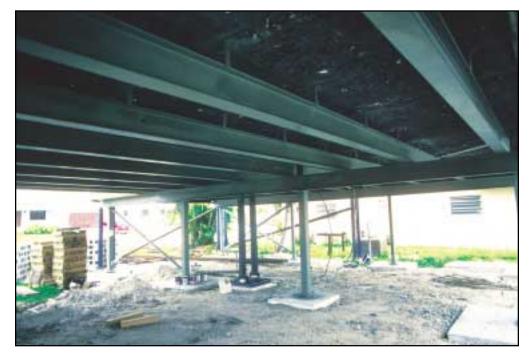
Figure 82 While the jacks and beams supported the house, new steel foundation members were installed below.

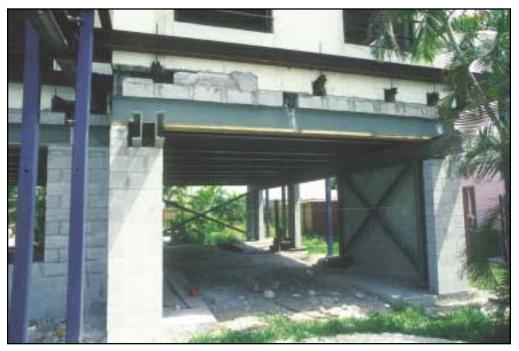
Figure 84 ... and used to build the lower-level walls.

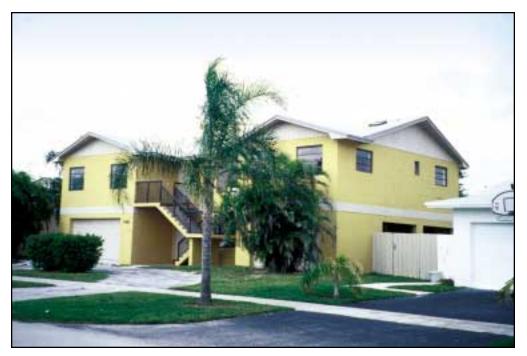
Figure 85

The completed house, with lowerlevel space for parking and storage and upper-level living space, looks as if it were originally designed and built as a two-story structure.
